Competitiveness in the Electronics Industry of Mexicali Affected by Atmospheric Corrosion

Gustavo **López-Badilla***
César **Sánchez-Ocampo**
Judith Marisela **Paz-Delgadillo**

Universidad Politécnica de Baja California
Dirección de Ingeniería en Tecnologías de Manufactura
Mexicali, Baja California.
MÉXICO.

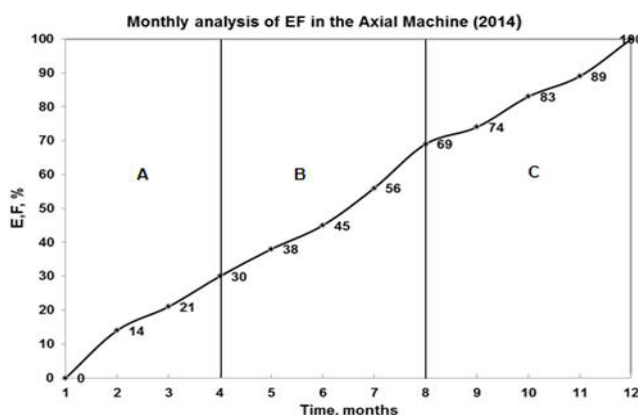
Fig. 1. Monthly Evaluation of the EF generated in the axial machines (2014).

The evaluations were performed with Graphics ABC, indicating the main types of causes of electrical failures in the industrial equipment and industrial machinery. Figure 1 shows the areas of the graph A, B and C, with the first three types of electrical failures, with the 30% that is the region A, along with the area B coupled to A 69% and completes the analysis area C represents a difference in the area before the end of 31%. Figure 1 is part of the evaluation of the radial machine in the time period, which shows that the first three types of power failures represent 30% which is the area A, and continuing with the region B reaches at 69% and finally reaching the area C, to the total percentage of 100%. Fig. 2 shows the radial percentage rates in the daily period machine, being 28% in zone A, 68% B and in totaling 100%, the region C, indicating that like the previous graphs of the electrical failures in the first three types represent about 70%. Fig. 2 is part of the analysis of the radial machine, showing the monthly period with the percentage levels of 28% in zone A, and then the B region with the 64%, and finally the area C indicating the 100%. In this graph, the differences between areas are contemplated to determine which of the five evaluated types of electrical failures, can be evaluated quickly and easily to phase out gradually the electrical failures that cause the concern of all staff working in this company. Assessments for the winter season in each year of study and in the axial machine were performed, being the electrical failures caused by others factors as minimum level. The analysis in Fig. 3 shows how the percentage rates of radial machine with a weekly evaluation in the region A being 27%, continuing the region B which exceeded 67% (71%) and ending area C which involves 100%.

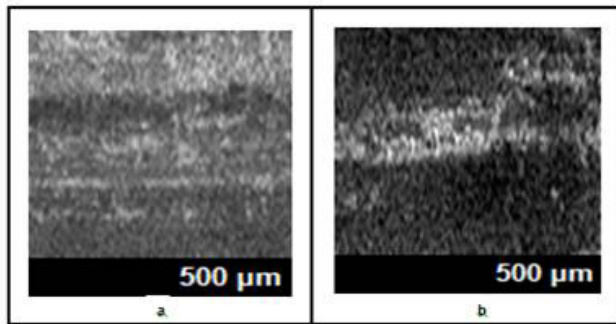
Fig. 4. Photomicrograph of deterioration of electrical connections of industrial equipment in the era of (a) summer and (b) winter.

Contaminants that adhered to the metallic surfaces caused the presence of corrosion and their percentages were evaluated through an analysis at the microscopic level where a deterioration in micrographs (Fig. 4) was observed. Fig. 4a showed the damage to the electrical connections of electronic equipment in the summer being a little clear and Fig. 4b is noted for winter obscurely, by the presence of moisture in as

many chances. This analysis describes in detail what happens on a microscopic scale.
